INTERNATIONAL JOURNAL OF WOOD CULTURE

# Timber Reuse in Mediaeval Churches of Finland

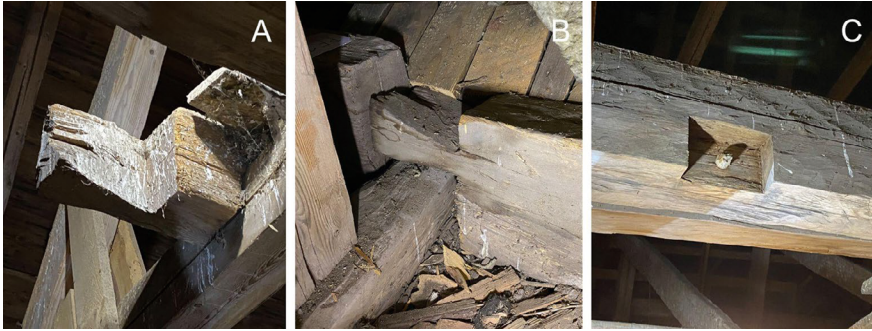
FIGURE 5 The reused timber in the nave roof structure of Pohja Church. (A) The joint of a wall log of the 14th century wooden church. The piece was reused as an anchor beam on the collar beams of the 1470s' structure © PANU SAVOLAINEN (2020). (B) The joint of a wall log of the 14th century wooden church. The piece was reused as an anchor beam on the wall plates © PANU SAVOLAINEN (2020). (C) A tie beam from the 14th century wooden church, reused as an anchor beam © PANU SAVOLAINEN (2020)

which were finally revealed as wall logs and roof tie beams of a wooden church, presumably the predecessor of the stone church of the 1470s. Of the 18 parts, four were tie beams and the other 14 were wall logs. All tie beams and most of the log walls contained carvings and numbering; crosses were also carved in the tie beams, which indicates a possible location on the roof of the choir of a wooden church. The meticulously hewn surfaces on all sides of the logs also indicate that the surfaces were likely finished to remain visible and serve as part of the architectural expression of the wooden church. Many of the log walls contained joints or the remains of joints (Fig. 5), which indicates that the building had a gable wall of approximately 7.6 metres.

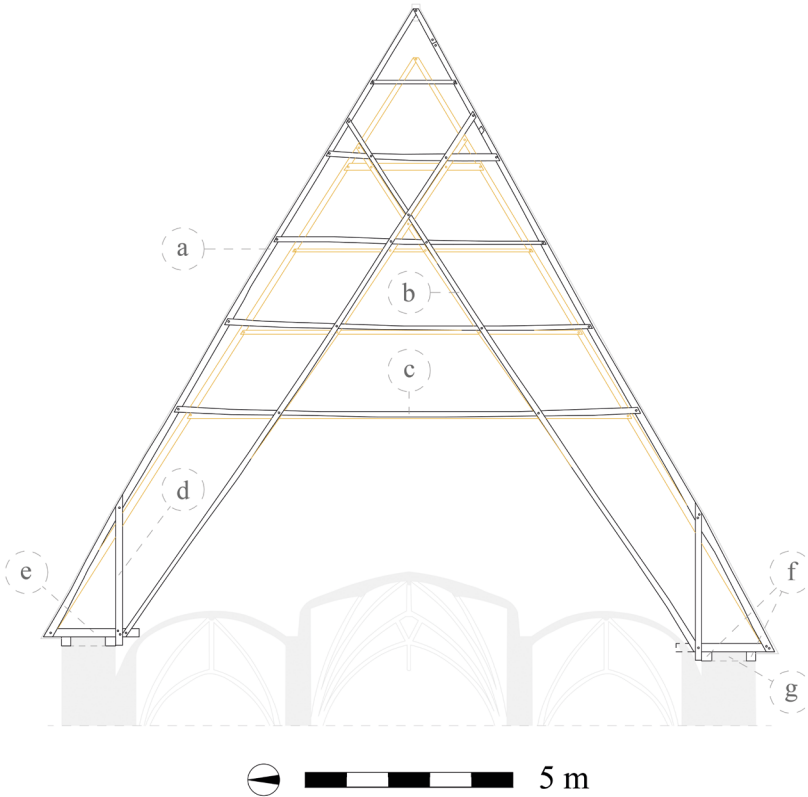
FIGURE 7 Nave roof truss scheme of Pyhtää Church. (Yellow) The possible original design with approximately  $57^\circ$  roof pitch. (Black) The built structure with approximately  $60^\circ$  roof pitch. (a) Rafter, (b) scissor beam, (c) collar beam, (d) ashlar post, (e) sole piece, (f) wall plates, (g) tie  
© FRANZISKA DALHEIMER AND ILARI AALTO (2024)

The remanufactured and reused pieces indicated that the alteration of the plans was related to changes in the roof pitch and height during the implementation of the construction project. All trusses for a lower roof had already been produced when, for reasons unknown, a decision was made to increase the height of the roof by approximately one metre. (Fig. 7). Because Pyhtää Church follows the same series of building plans as the churches built decades earlier in Sipoo, Pernaja, Porvoo, Vehkalahti, and Helsinki Parish, it seems plausible that such alterations were intended to individualise the church by giving it a comparably taller structure (Hiekkanen 1994: p. 218; Savolainen *et al.* 2020: p. 21). Although Pyhtää Church's floor plan is not larger than those of the other churches, there appears to have been a clear intention to construct walls as high as those of the roughly 10-years-old Helsinki Parish Church, which featured an even higher and steeper roof. The exact motives, especially whether this was done to gain higher prestige than other churches or to receive more

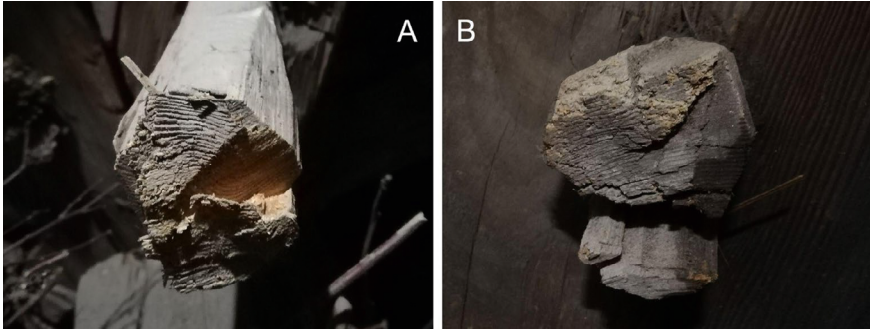
FIGURE 11 Dowel profiles in Pyhtää Church with a different wood grain pattern  
© FRANZISKA DALHEIMER (2023)

Dowels belong to the original structure and can provide information on the management of the smaller waste parts of timber, leading to possible recycling. Figure 11 shows the profile of dowels in the nave roof structure of Pyhtää Church, microscopically identified as both pine and spruce (Dalheimer & Aakala, 2024: p. 48). The grain pattern indicated that both tree branches and scrap wood from sapwood were used for the dowels. Approximately 750 dowels with a length of around 30 cm and a diameter that corresponds to a bore size of 3.8 cm were needed for the whole nave roof structure of Pyhtää Church. They were likely composed of waste from manufacturing processes.
